DEPARTMENT OF TRANSPORTATION

Quality Assurance and Source Inspection

Contract #: 04-0120F4Cty: SF/ALA Rte: 80 PM: 13.2/13.9File #: 99.28**WELDING INSPECTION REPORT****Resident Engineer:**Siegenthaler, Peter**Address:** 333 Burma Road**City:** Oakland, CA 94607**Report No:** WIR-023559**Date Inspected:** 12-May-2011**Project Name:** SAS Superstructure**OSM Arrival Time:** 700**Prime Contractor:** American Bridge/Fluor Enterprises, a JV**OSM Departure Time:** 1900**Contractor:** Zhenhua Port Machinery Company, Ltd (ZPMC), Changxing Island **Location:** Shanghai

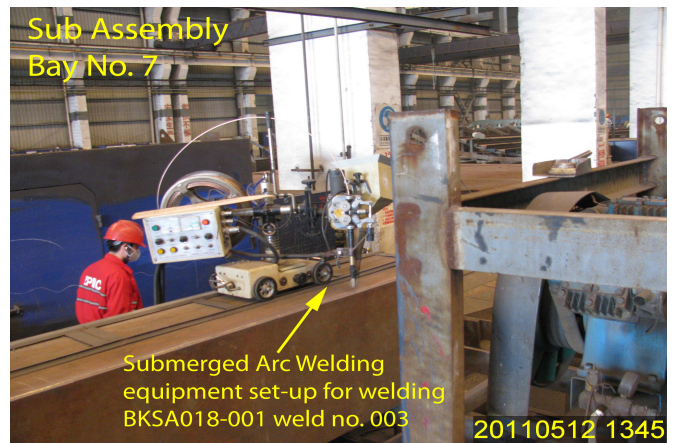
Unless otherwise noted above all items observed on this day appeared to be in general compliance with the applicable contract documents
